### **Ground Penetrating Radar (GPR) Survey For the Flandreau Santee Sioux Buffalo Pasture**

Flandreau Santee Sioux Tribe Flandreau, South Dakota

> Prepared By: Steve Babits, P.G. WREQC Geologist

September 26, 2011

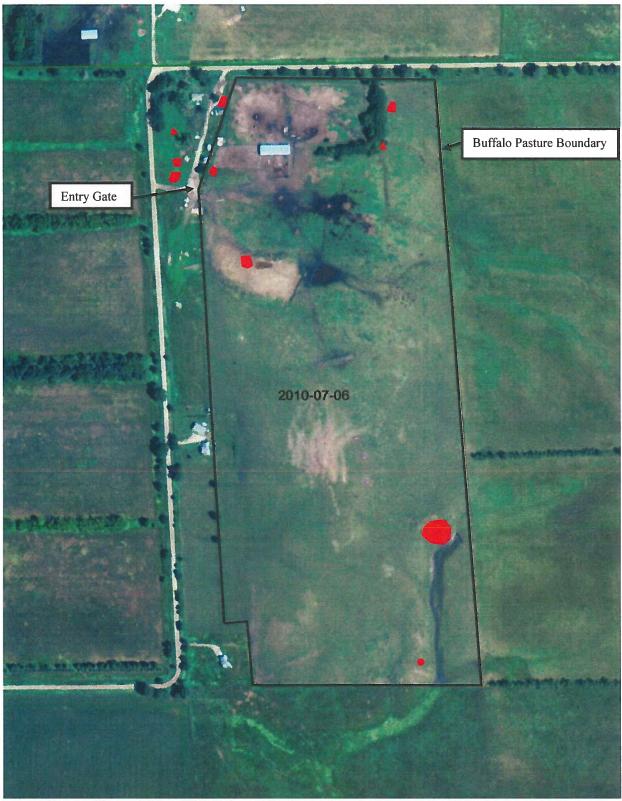
Figure 2. Site Detail Map, GPR Survey, Flandreau Santee Sioux Tribe Buffalo Pasture. Areas of interest are shown in red. Based on July 6, 2010 aerial photograph.

Several areas of interest were identified during the GPR survey where buried material is suspected. These areas were marked in the field with orange pin flags and are also indicated on the Site Map on Figure 2. These areas are described in more detail below.

GPR profiling indicated additional buried metallic debris in an area west of the spring near the southeast corner of the buffalo pasture. Some solid waste was already reportedly removed from the spring area and scattered debris is visible on the surface and partially buried within the flagged area. Another potential buried target was located further to the south on the west side of the drainage downstream of the spring, near the buffalo pasture boundary fence.

Trash was reportedly disposed in the excavated area southeast of the buffalo pasture entry gate. GPR profiling in this location indicated an area of metallic and non-metallic buried debris west of the small pond within the excavated area.

Another area of interest was found near the northeast corner of the site. Many non-metallic targets were identified and marked here. It is also possible that these targets are buried boulders. Potential targets were also found within the buffalo pasture just north of the gate, as shown on Figure 2.

Outside of the buffalo pasture, several areas of interest were identified and marked on the northwest corner of the Site. Some solid waste items such as paint cans were observed on the surface and partially buried, and additional buried waste is possible.

The several areas of interest that were marked in the field during the GPR survey and which are indicated on Figure 2 should be investigated further to determine if buried debris is present. Direct excavation of these areas to a depth of at least 3 or 4 feet using a backhoe or other suitable equipment is recommended.

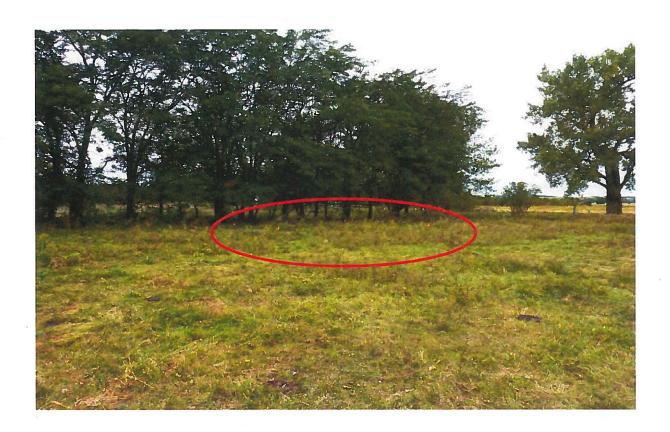
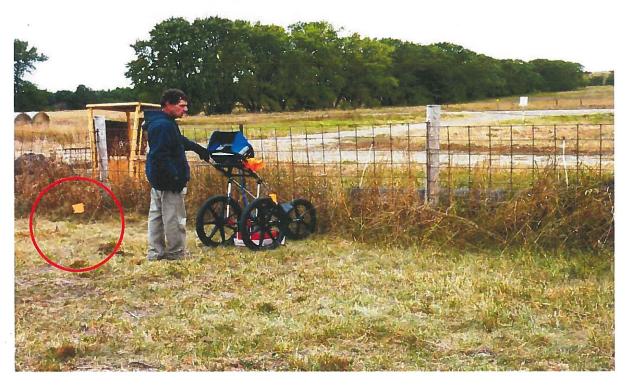
Examples of areas of interest that were identified in the northeast corner of the Site and north of the gate into the buffalo pasture. Such areas were marked with pin flags.
