### **Ground Penetrating Radar (GPR) Survey For the Flandreau Santee Sioux Buffalo Pasture**

Flandreau Santee Sioux Tribe Flandreau, South Dakota

> Prepared By: Steve Babits, P.G. WREQC Geologist

September 26, 2011

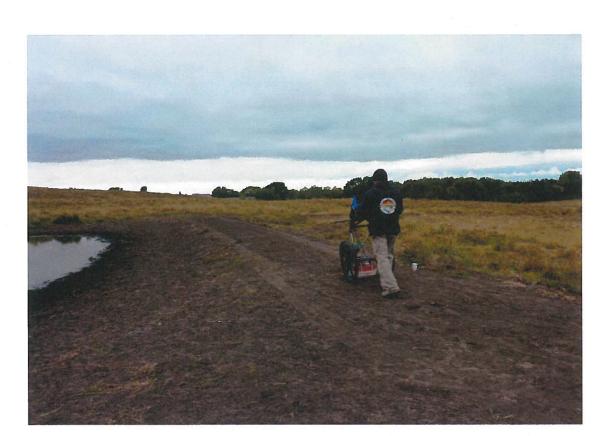
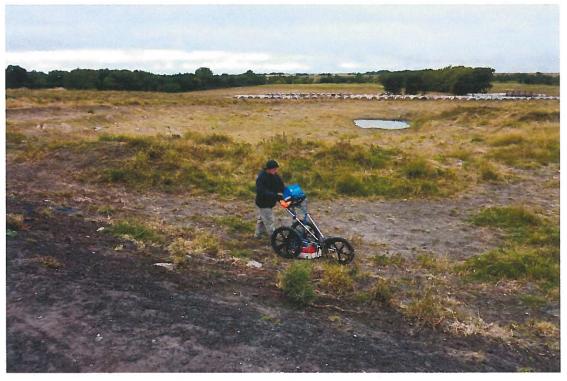
GPR data collection using the GSSI Utility Scan System in the buffalo pasture near the excavated area and stock pond.

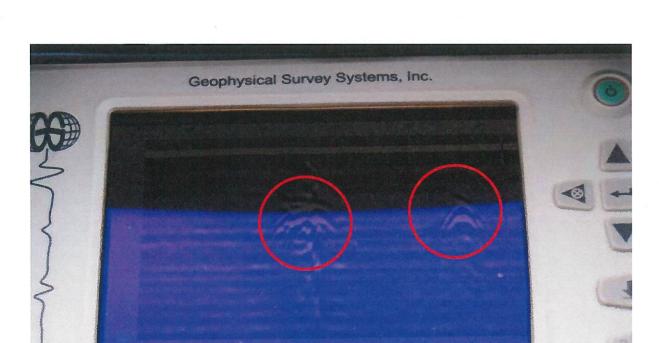
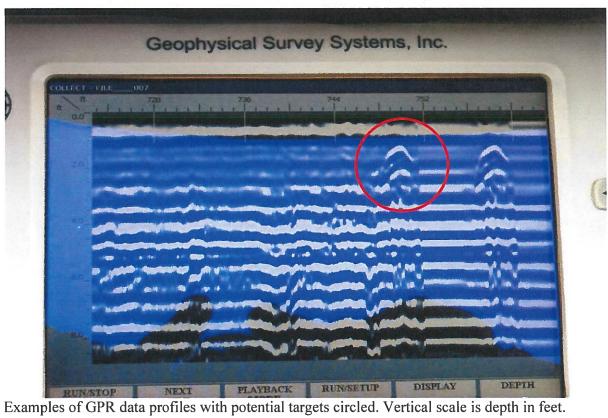
Another area of interest was found near the northeast corner of the site. Many non-metallic targets were identified and marked here. It is also possible that these targets are buried boulders. Potential targets were also found within the buffalo pasture just north of the gate, as shown on Figure 2.

Examples of areas of interest that were identified in the northeast corner of the Site and north of the gate into the buffalo pasture. Such areas were marked with pin flags.

The several areas of interest that were marked in the field during the GPR survey and which are indicated on Figure 2 should be investigated further to determine if buried debris is present. Direct excavation of these areas to a depth of at least 3 or 4 feet using a backhoe or other suitable equipment is recommended.
